NASA Contractor Report 166011

DESIGN, ANCILLARY TESTING, ANALYSIS, AND FABRICATION DATA FOR THE ADVANCED COMPOSITE STABILIZER FOR BOEING 737 AIRCRAFT

VOLUME II—FINAL REPORT

BOEING COMMERCIAL AIRPLANE COMPANY
P.O. BOX 3707, SEATTLE, WA 98124

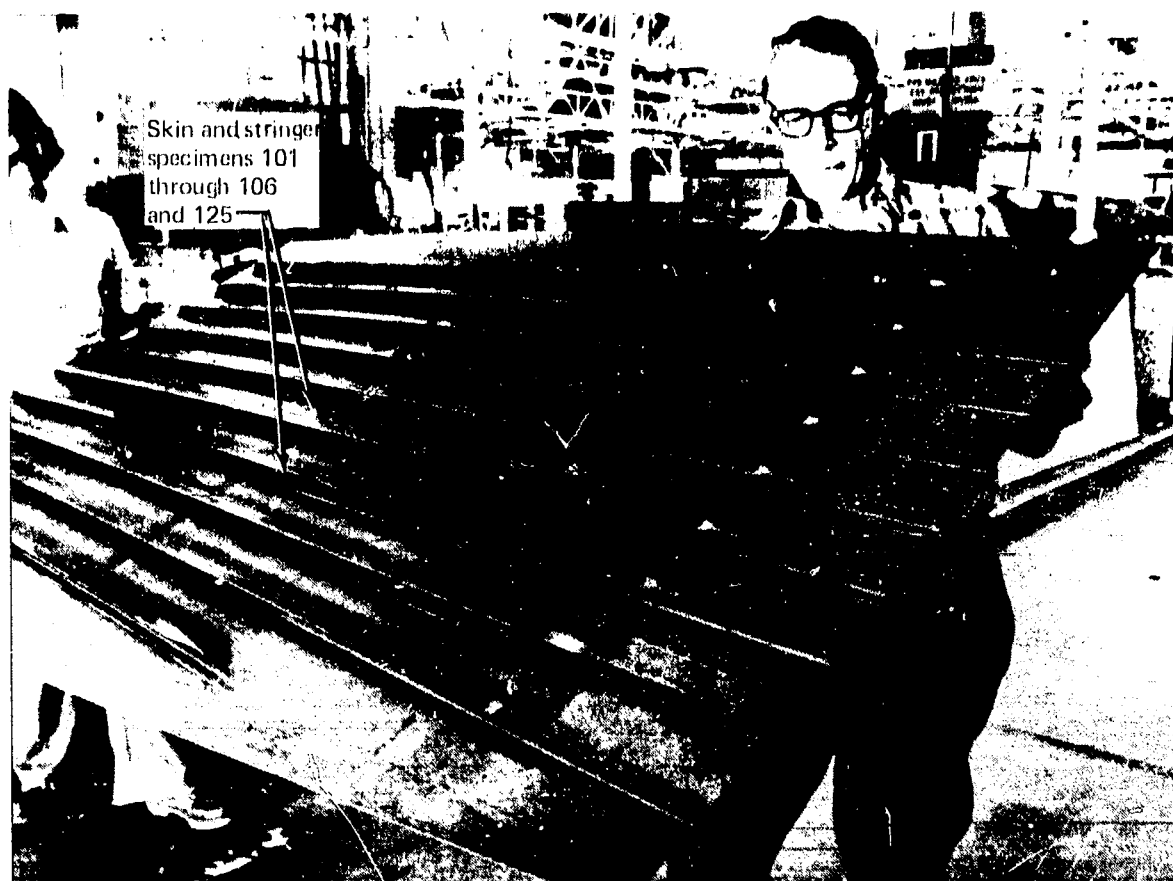
Figure 127. Stabilizer Stub Box Skin

Production verification (Test 25) was conducted to determine baseline material properties of critical sections of the stabilizer that had been fabricated on production tools (fig. 126). Specimens were cut from production tool tryout sections of skin panels, ribs, and spars in the areas defined in Figures 127 through 130. The test results are presented in Tables 25 through 27, and the detail specimen dimensions are shown in Figure 131.

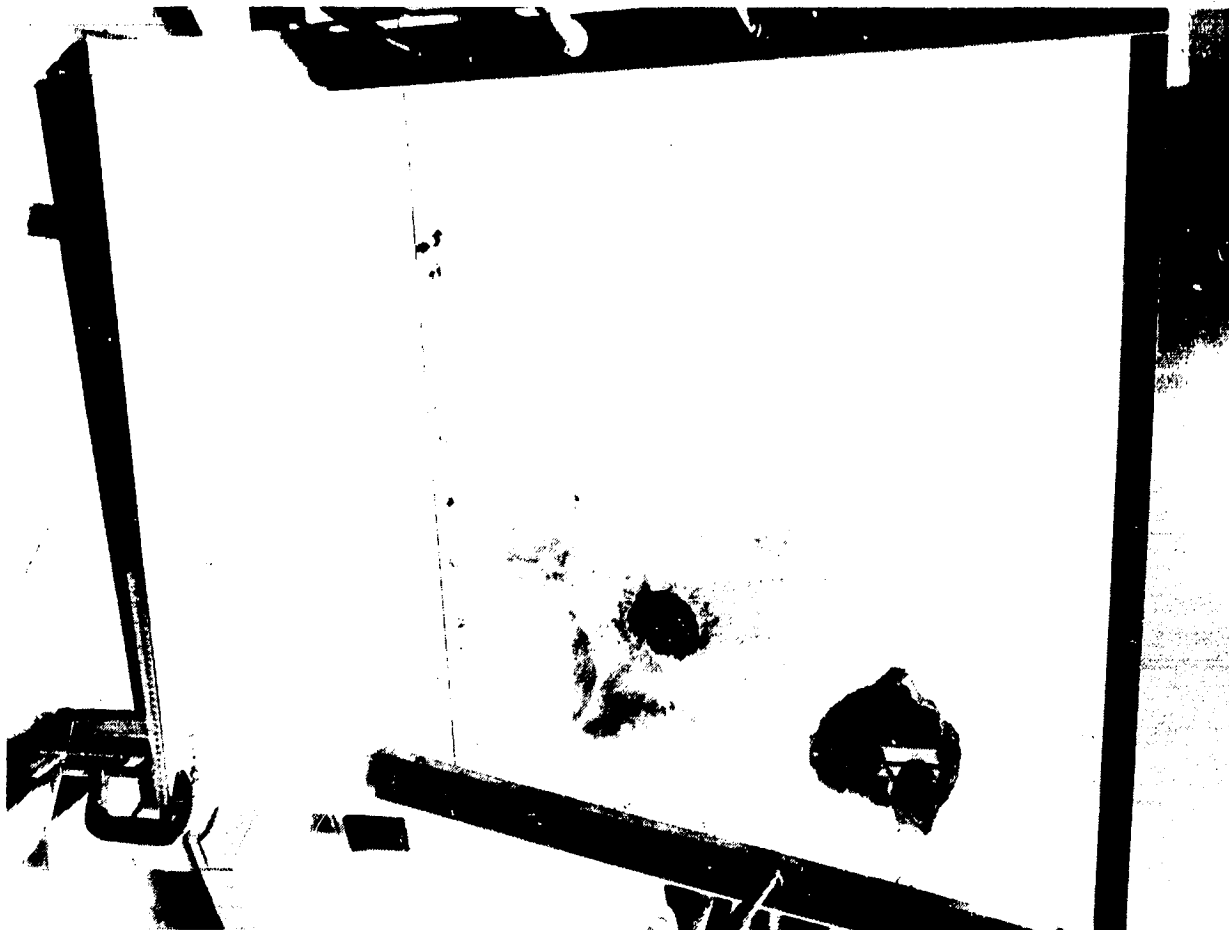
Figure 136. Lightning Strike Test, Outer Surface

The first series of tests (figs. 136 and 137) resulted in penetration of the skin and delamination of the stringers. Review of the test specimen and data showed that the peak current was 29% high, the energy of the strike (action integral) exceeded requirements by approximately 115%, and the support system for the test panel was not consistent with the flight hardware. Based on this review, additional panels were manufactured and tested.

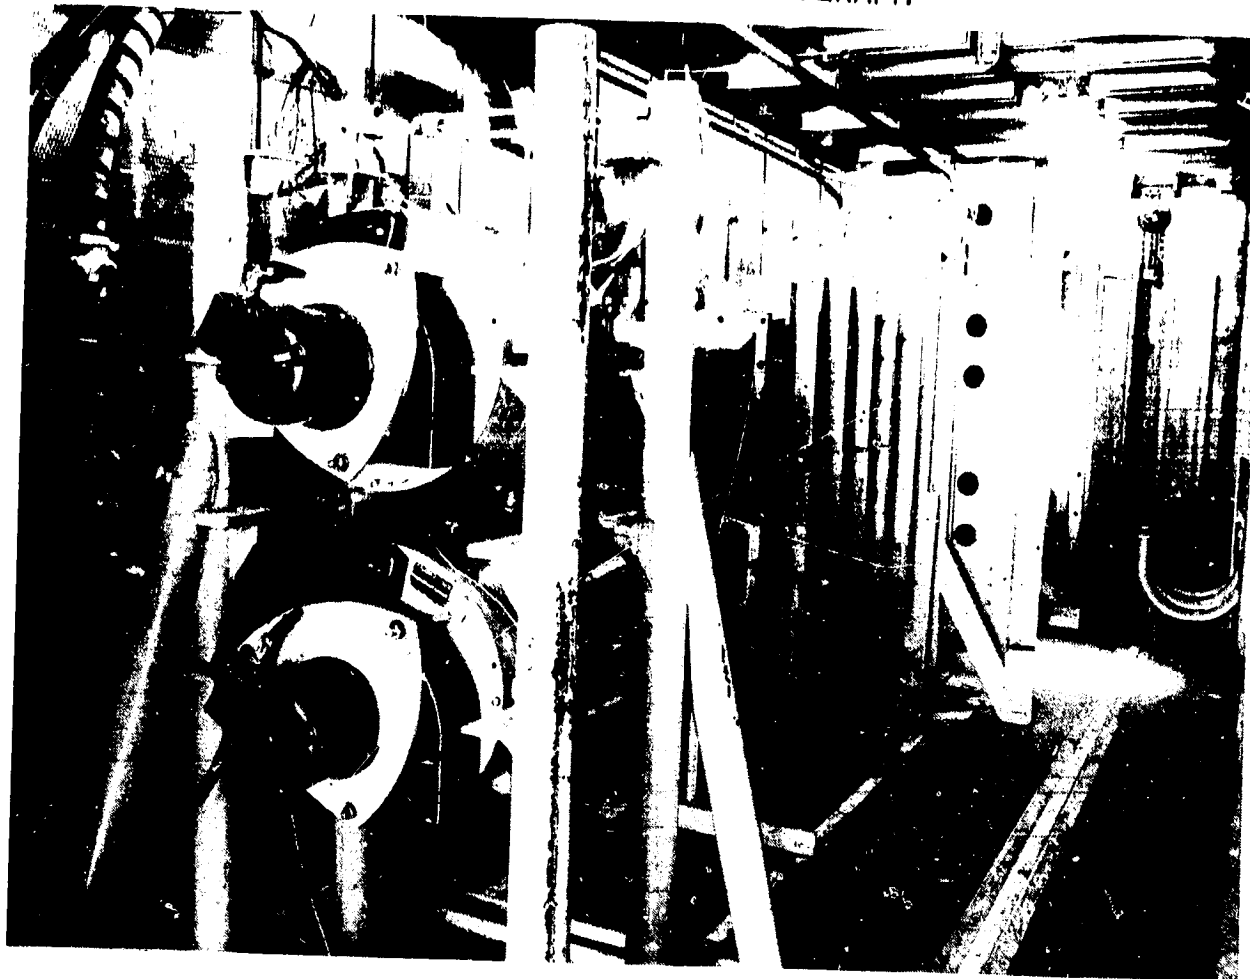
Figure 141. Sonic Box Test Setup

The test specimen was mounted in a 50-Hz grazing incidence horn as shown in Figure 141. Sine scans were conducted to establish the first three resonant frequencies. Mode shapes and node lines were defined. The specimen then was subjected to the following overall sonic pressure levels (OASPL) during the first phase of tests:

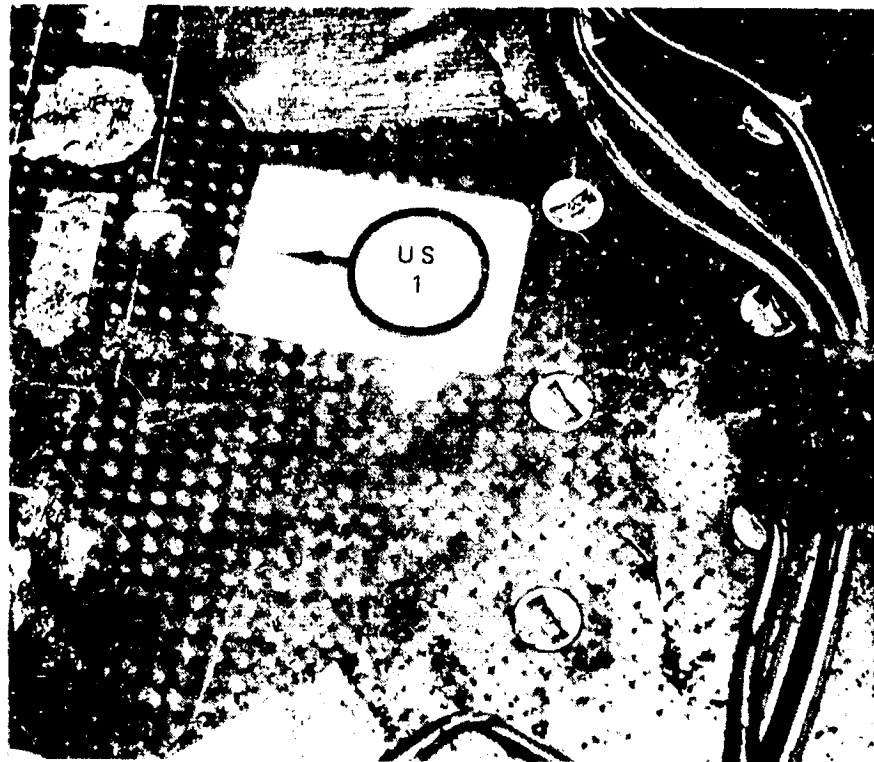
Figure 151. Upper Surface Damage (US-1)

Damage Tolerance Growth Assessment—Damage tolerance testing evaluated the effects of repeated loads on discrete damage. Damage was inflicted at critical locations. A description of the damage is shown on Table 32 and in Figures 146 through 148. Photos of examples of damage are shown in Figures 149 through 152.

US-1	Upper skin (same as LS-1)	Impact damage. Simulates dropped tool or hail damage

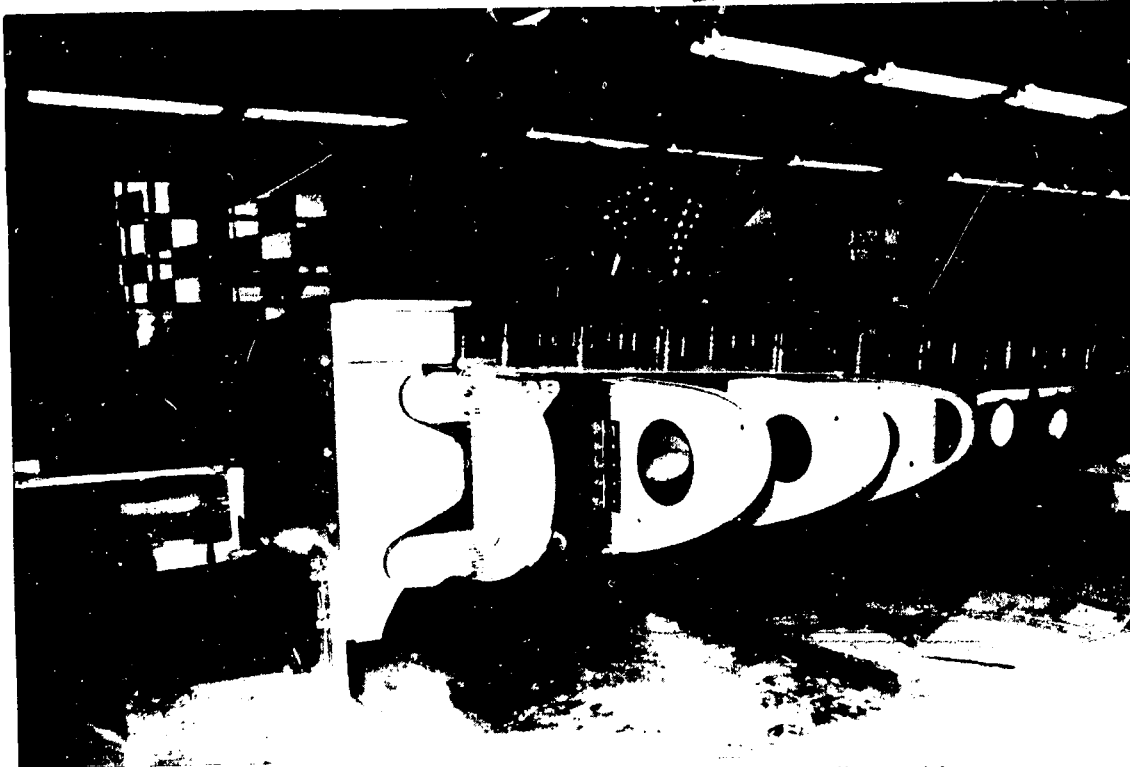
Figure 247. Stub Box—Front Spar, Aluminum Nose Ribs, and Lower Skin in Place (Test 21)

Stub Box—This test part was produced as manufacturing verification hardware and is discussed in Section 5.3 and illustrated in Figures 231 through 254 (Test 21).

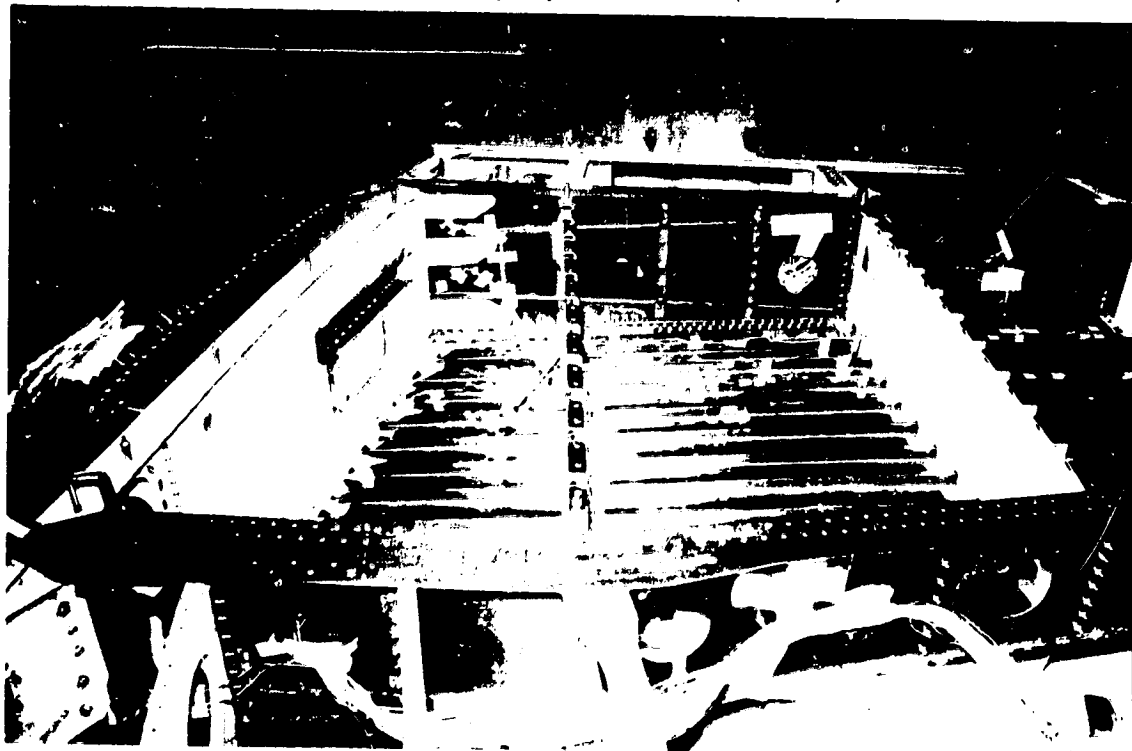
Figure 250. Stub Box—Front and Rear Spar, Lower Skin Panel, and Ribs With Instrumentation (Test 21)
